Memorandum - Enforcement Confidential

Subj: NPDES Compliance Sampling Inspection
Municipal Separate Storm Sewer System (MS4)
City of Chelsea, MA

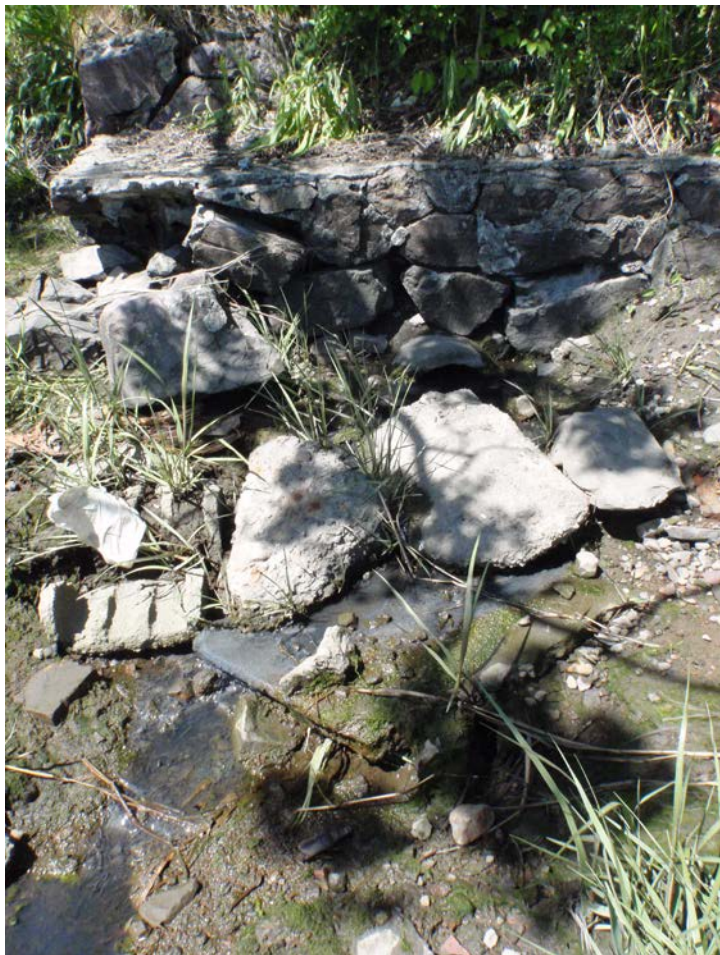
Photo 2: 5/26/09 10:43 AM. View of sample unnamed outfall and sample location “Mill2b” approximately 100 yards west of “Mill2b”. Note gray bacterial plaque downstream of outfall.

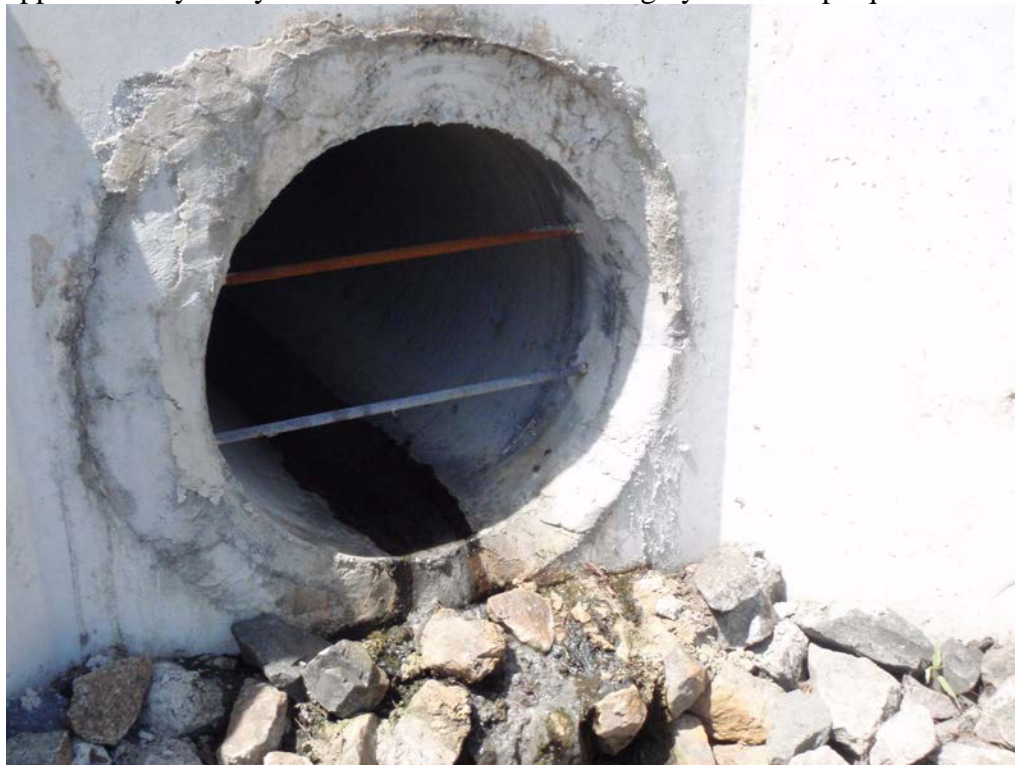
Photo 3: 5/26/09 11:05 AM. View of unnamed outfall and “Mill2a” sample location. Note gray

bacterial plaque in bottom of outfall pipe and on rocks beneath pipe.

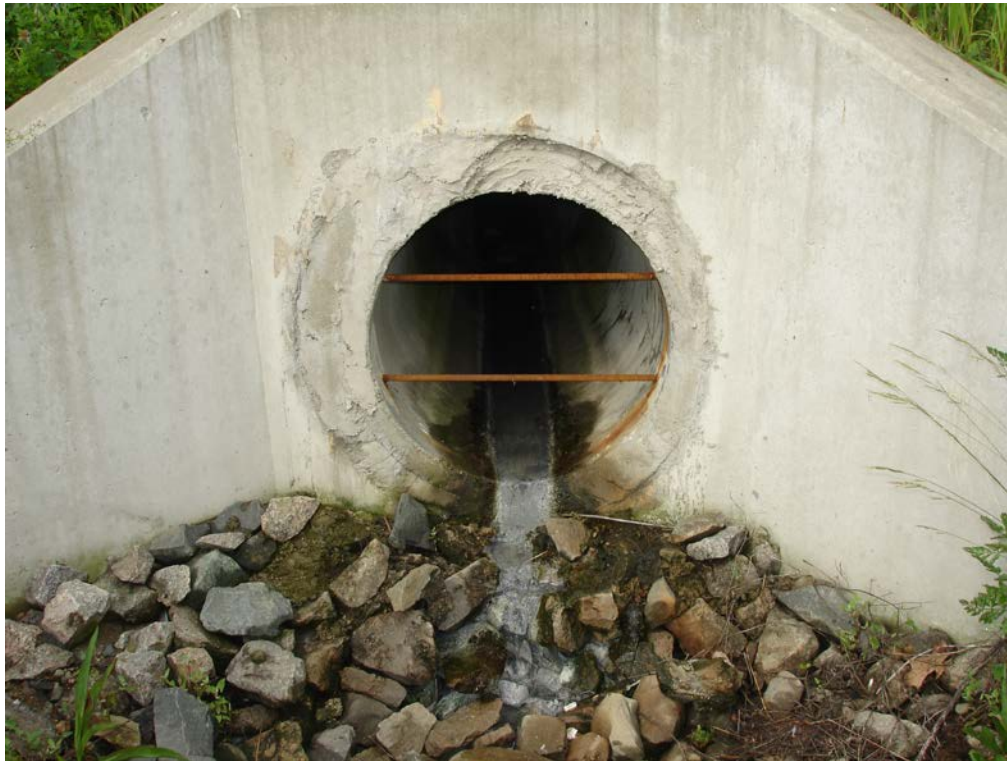
At approximately 8:50 hours EPA sampled an unnamed outfall (sample id "Mill2a") located approximately 50 yards west of "Mill2" outfall discussed below. This outfall is an approximate 24-inch concrete pipe in a concrete headwall and appeared to be of recent construction. EPA noted flow of approximately 3 gallons per minute, strong odor with a chemical edge, some suds on water surface, gray and cloudy water, and significant gray bacterial plaque within and beneath the outfall pipe. Using Hach brand test strips for ammonia and a Chemetrics K-9400 field kit for surfactants, EPA processed a surface water sample collected at the location. Field kits indicated elevated levels of ammonia (4.0 mg/l) and surfactants (0.5 mg/l) in the sample. EPA personnel typically use 0.5 mg/l ammonia and 0.25 mg/l surfactants as threshold level screening concentrations, where sample results equal to or greater than these concentrations may be indicative of illicit discharges. A sample was collected and sent back to the EPA laboratory to be analyzed for e. coli and enterococcus bacteria, and selected pharmaceutical compounds.

Photo 1: 6/22/11 8:50 AM. View of unnamed outfall and “Mill2a” sample location. Note gray bacterial plaque in bottom of outfall pipe and on rocks beneath pipe.

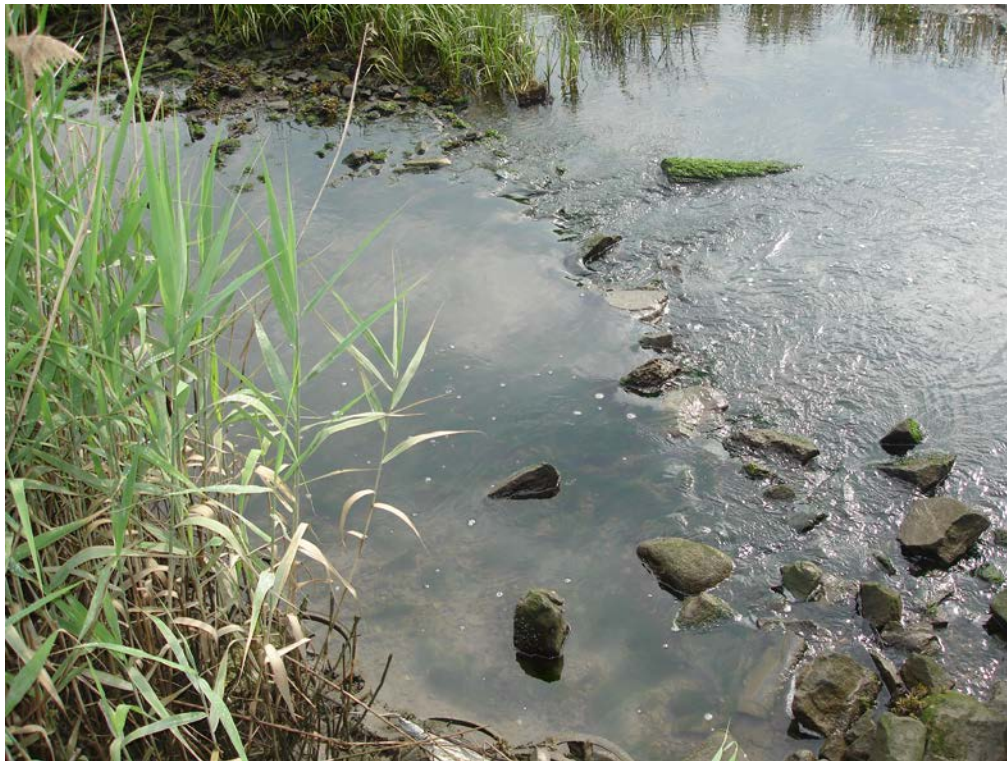
At approximately 0905 EPA sampled Mill Creek approximately 6 feet upstream of where the discharge from the Mill2A sample location entered the stream. Stream flow was sufficient to ensure the no mixing had occurred between the stream and the Mill2A discharge, and the sample should be considered indicative of upstream conditions. The stream was shallow (<6 inches in depth) and clear during sampling, which occurred on an outgoing tide. The stream is tidally influenced and low tide would occur at approximately 1049 hours. Using Hach brand test strips for ammonia and a Chemetrics K-9400 field kit for surfactants, EPA processed a surface water sample collected at the location. Field kits indicated no detectable levels of ammonia, elevated levels of surfactants (2.0 mg/l) in the sample, although EPA notes this reading is likely due at

Photo 2: 6/22/11 0905 AM. View of unnamed “MillCr1” sample location in Mill Creek just upstream of where “Mill2a” discharge enters stream.

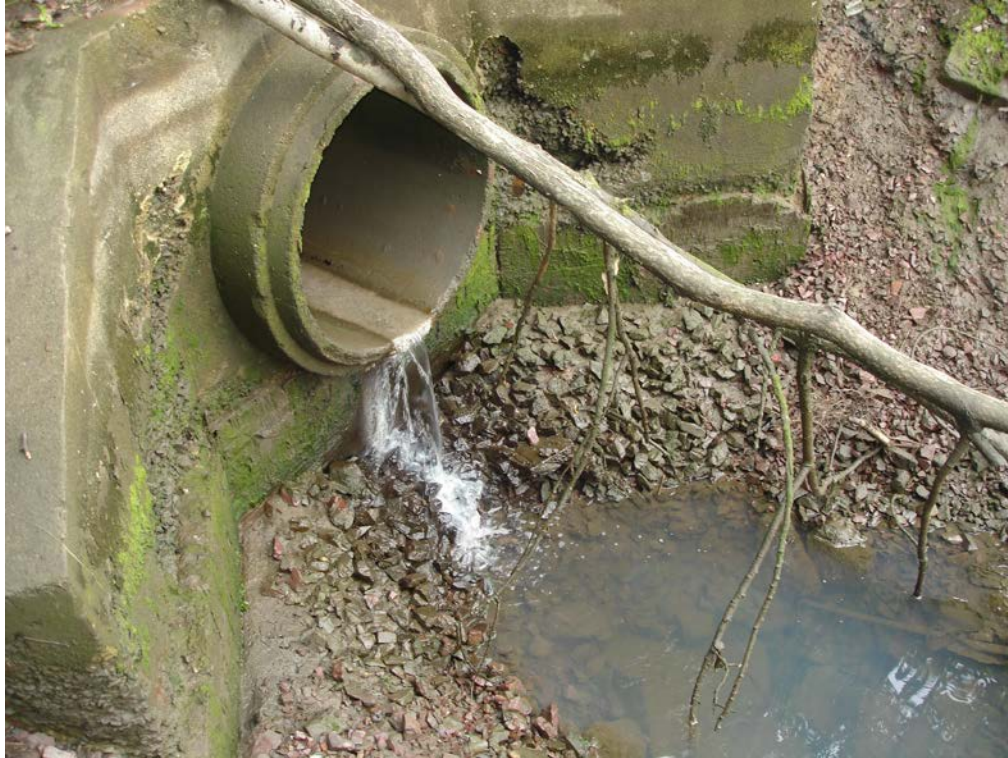
At approximately 9:15 hours EPA sampled the Gillooly Road outfall (sample id "Mill2"). This outfall is an approximate 30-inch concrete pipe. EPA noted flow of approximately 10 gallons per minute, a strong musty odor, gray bacterial plaque in the outfall pipe and the rocks below. Using Hach brand test strips for ammonia and a Chemetrics K-9400 field kit for surfactants, EPA processed a surface water sample collected at the location. Field kits indicated elevated levels of ammonia (3.0 mg/l) and surfactants (1.0 mg/l) in the sample. A sample was collected and sent back to the EPA laboratory for analyses for e. coli and enterococcus bacteria, and selected pharmaceutical compounds.

Photo 3: 6/22/11 0915 AM. View of Gillooly Street outfall and “Mill2” sample location. Note gray bacterial plaque in bottom of outfall pipe and on rocks beneath pipe, in addition to the cloudy gray appearance of the plunge pool below the outfall.

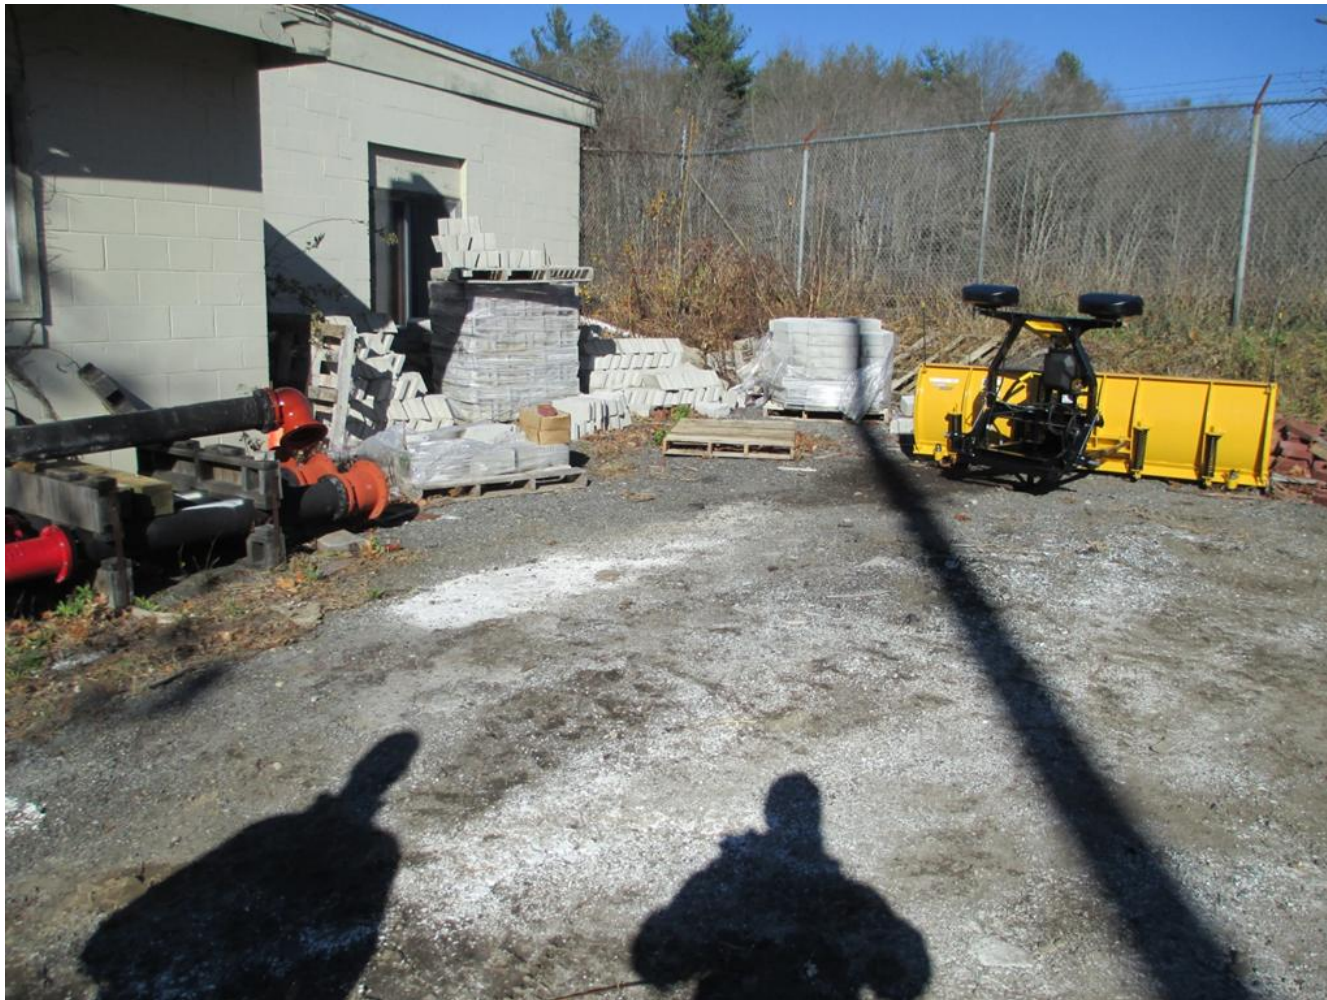
Photo	Date	Location	Subject
4	11/19/2013	DPW yard	Material storage area 1

Outdoor material storage area 1 (Photos 4 and 5) contained construction materials such as concrete blocks and manhole structures. Outdoor material storage area 2 (not pictured) included materials such as sands and loam that may be transported by storm waters. Salt is stored inside, but is loaded on trucks for spreading outdoors (Photo 6). No facilities are provided for washing of vehicles and Mr. Haines stated that vehicles are not washed at all.

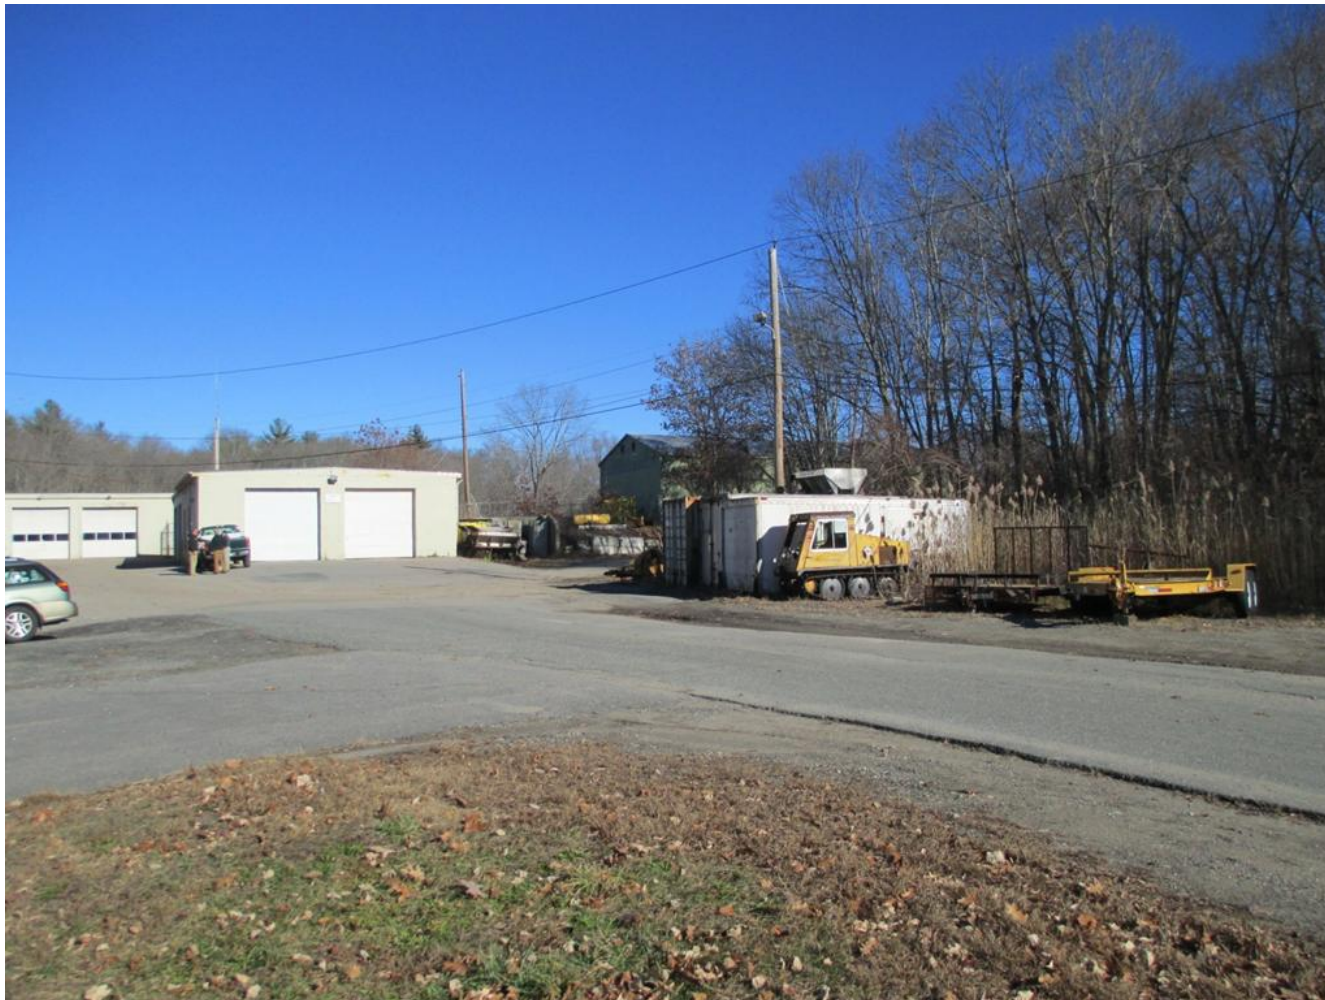
Photo	Date	Location	Subject
7	11/19/2013	DPW yard	Willow Street

The DPW yard is graded so that storm water from the salt loading area and outdoor material storage area 2 flows across Willow Avenue into the Willow Brook (Photos 7-9). No control structures are provided to treat storm water and erosion is visible near the outfall (Photo 8).

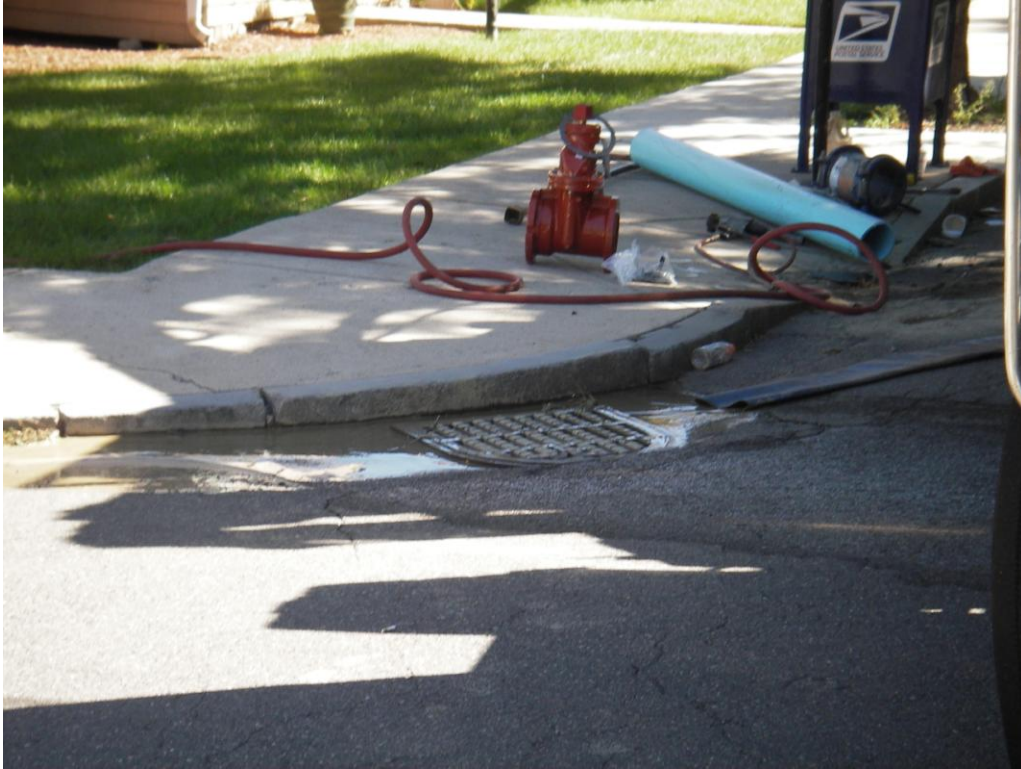
View of pumped groundwater conveyed to MS4.

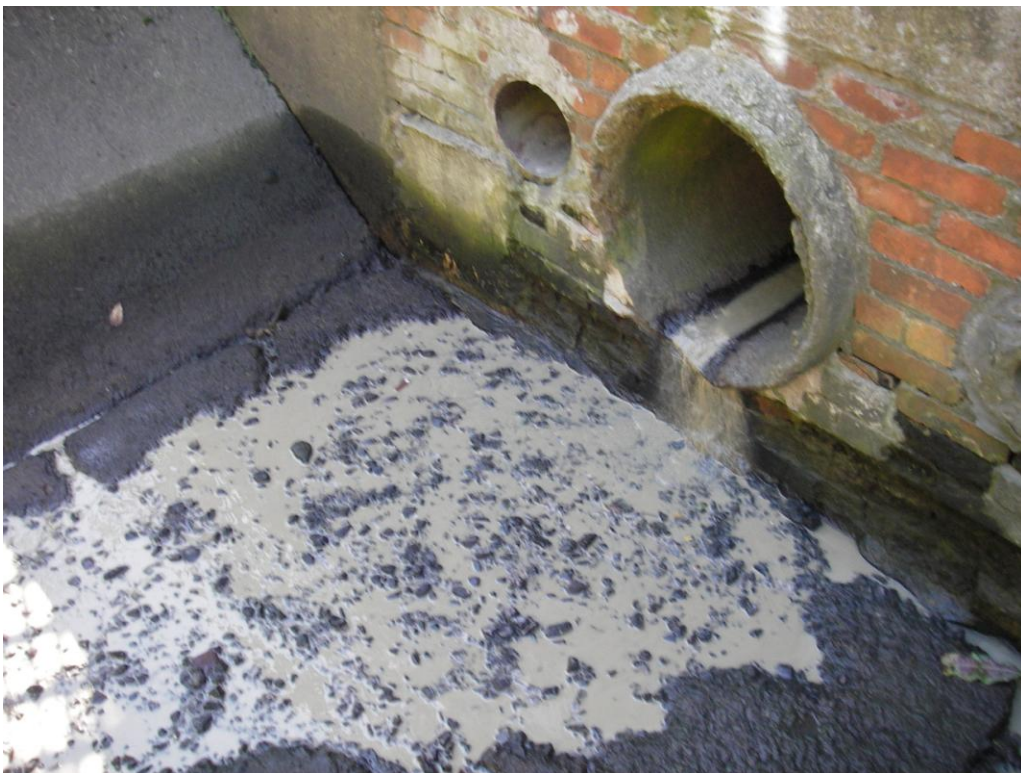
View of turbid discharge from outfall TL-9 located at the east end of Hadley Street in Malden, Massachusetts.

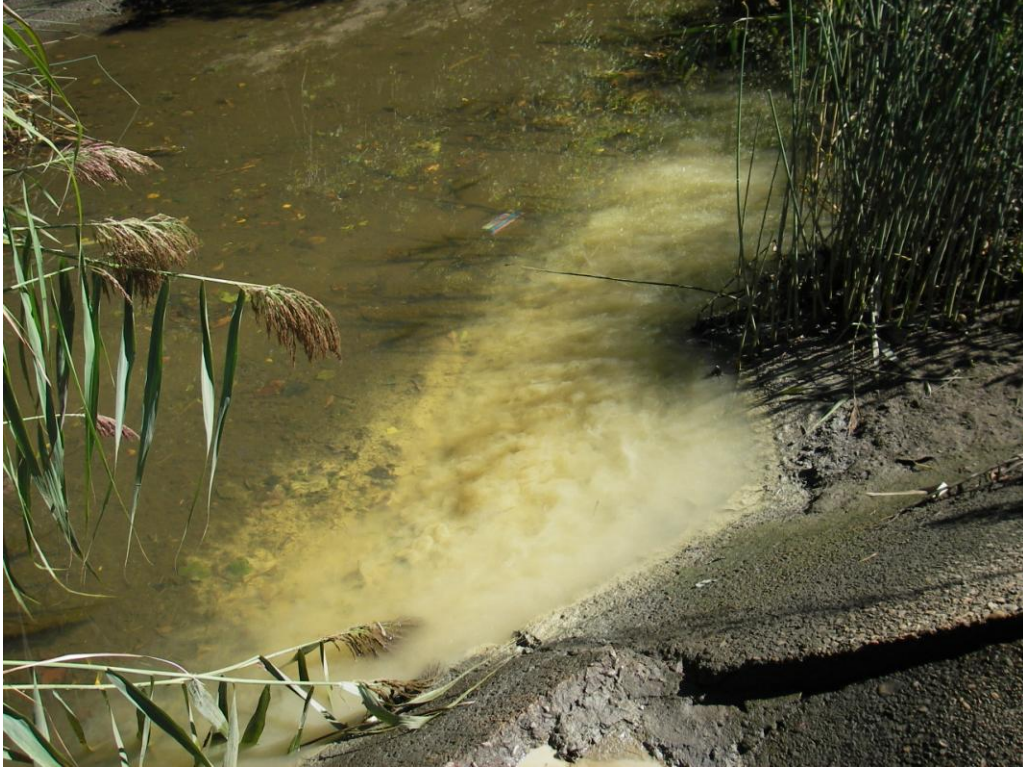
View of turbid plume entering Town Line Brook.

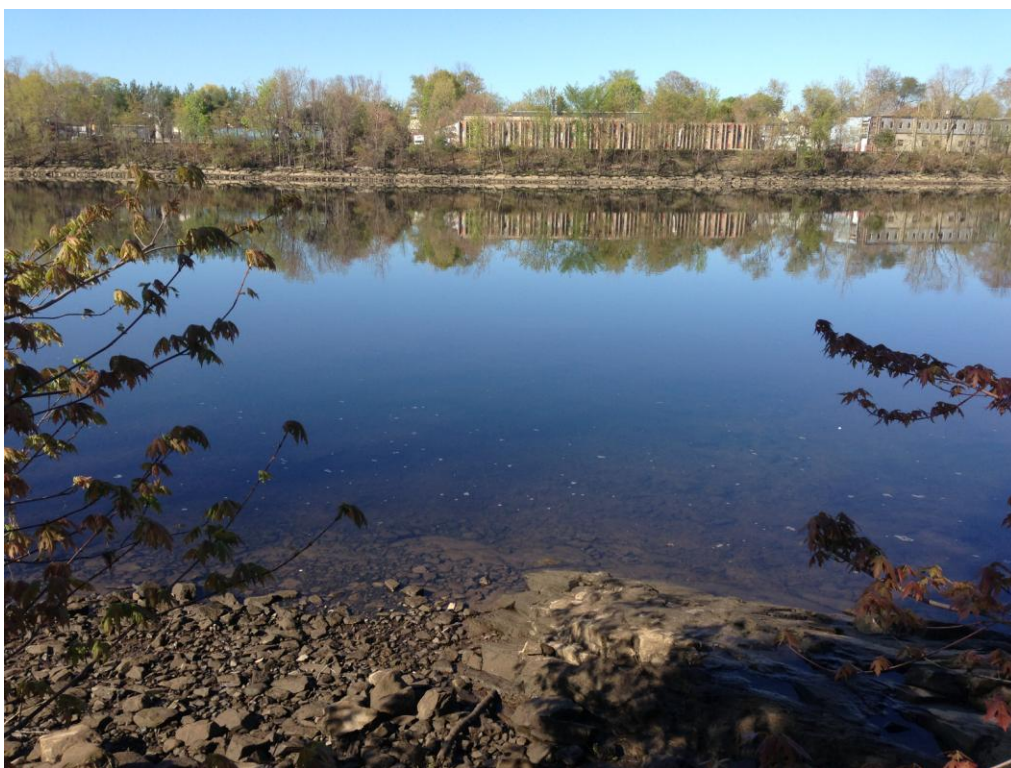
Photo 2: Location MR01 on north bank of Merrimack River approximately 50 feet upstream of BWOOD1.

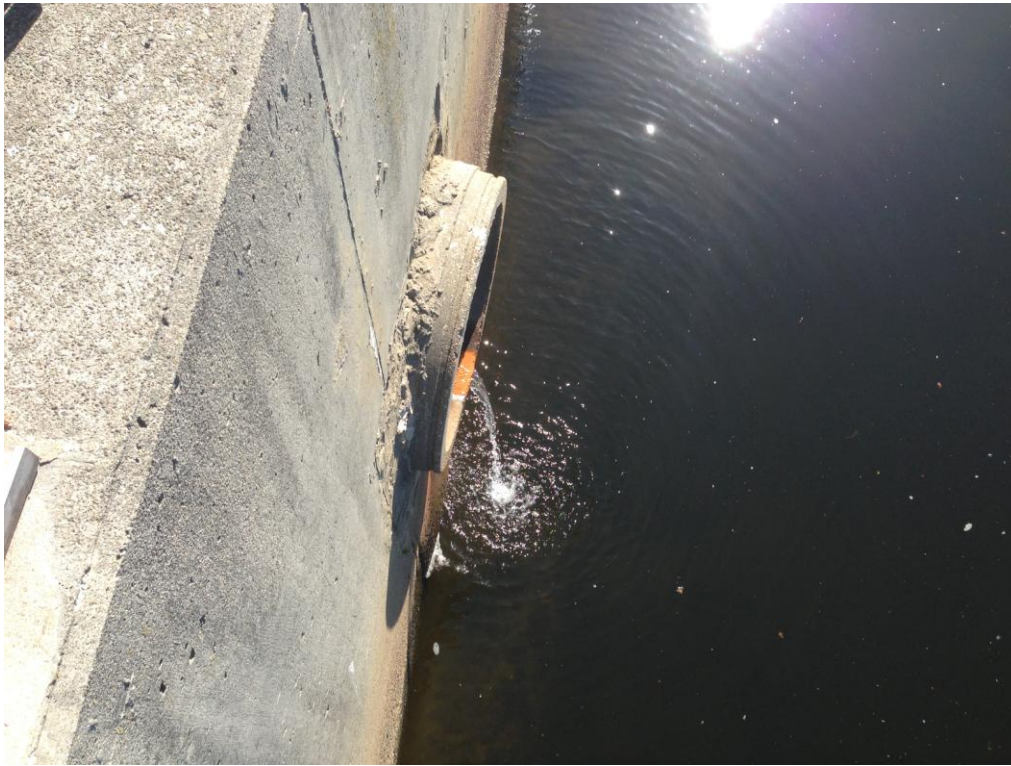
Photo 3: Sample location Beth1- note orange sediment in pipe.

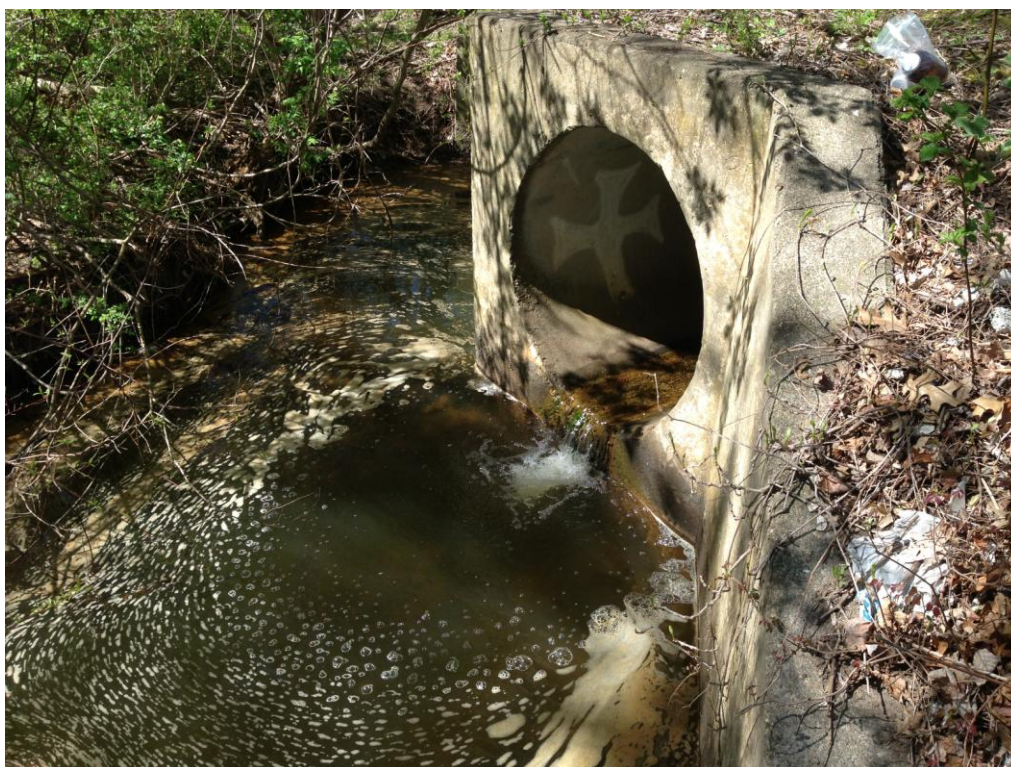
Photo 5: Location Cash02- south of Cashman Field on Hilldale Ave – Cash01 is obscured by the larger Cash02 outfall – note brown foam.

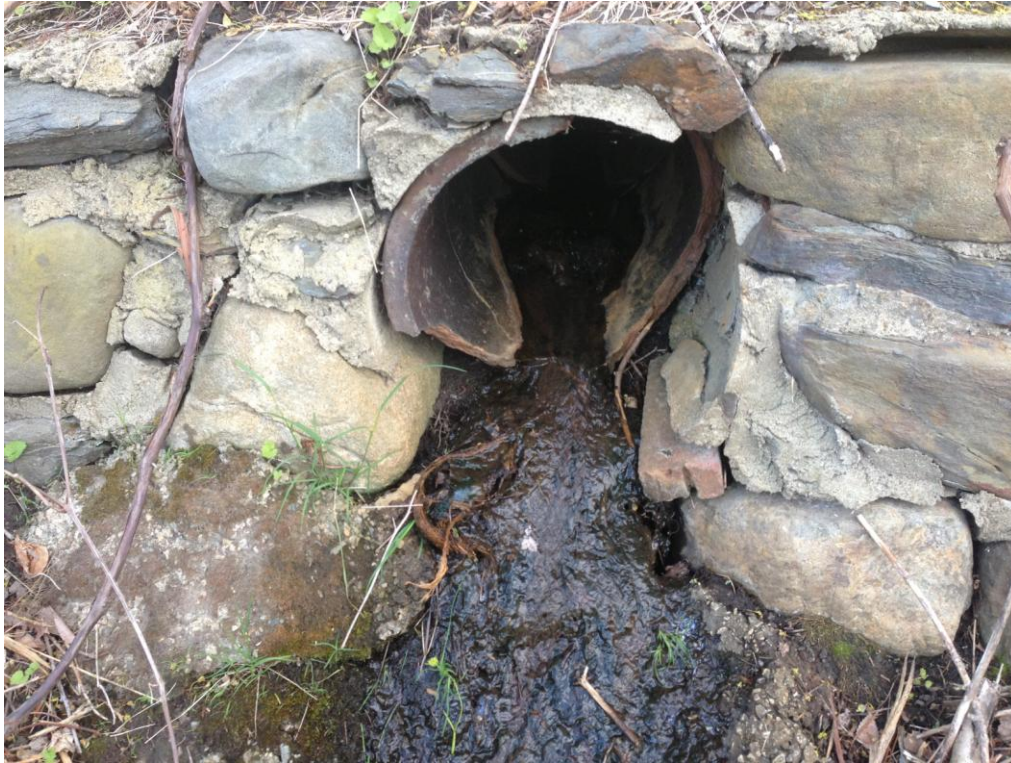
Photo 1: Outfall is location BWOOD1 – note bacterial/algae growth.

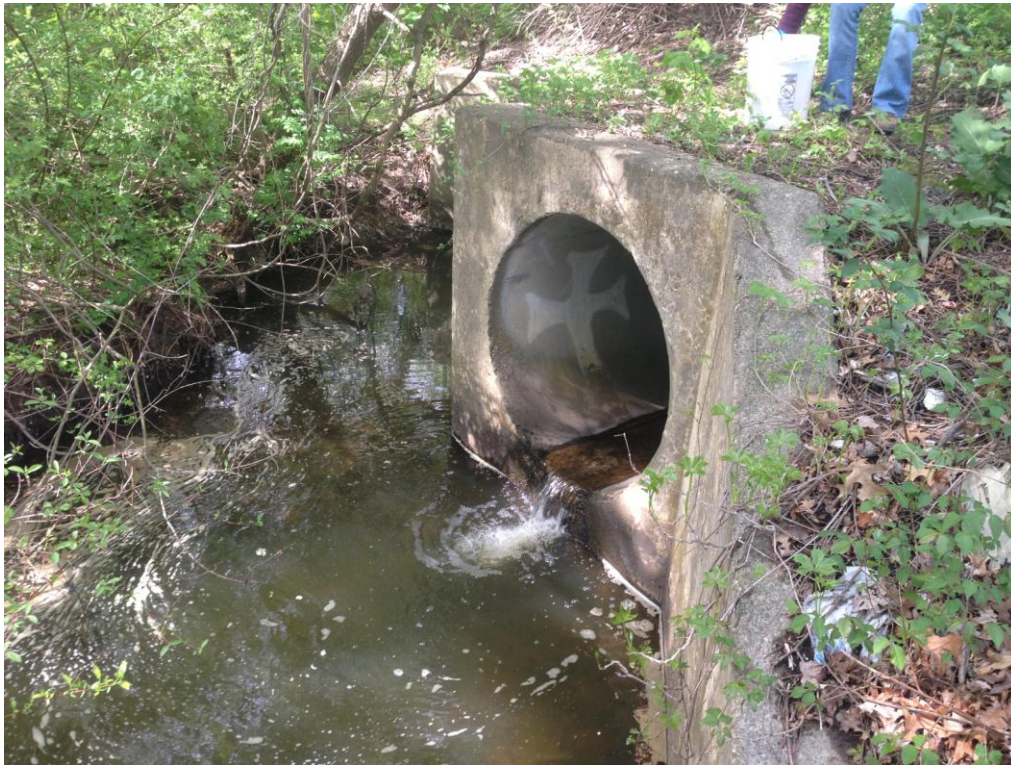
Photo 5: Location Cash02- south of Cashman Field on Hilldale Ave – Cash01 is obscured by the larger Cash02 outfall – note brown foam.
